LONG LAKE LEVEL CONTROL STRUCTURE PART 307 INSPECTION

Dam Identification No.: 2555
Hazard Potential: Low
Section 17, T. 16 N. – R.08 W.
Chippewa Township, Mecosta County, Michigan

Date of Inspection: April 4, 2017
Date of Report: April 2017

Project I.D. Number 124563SG2017

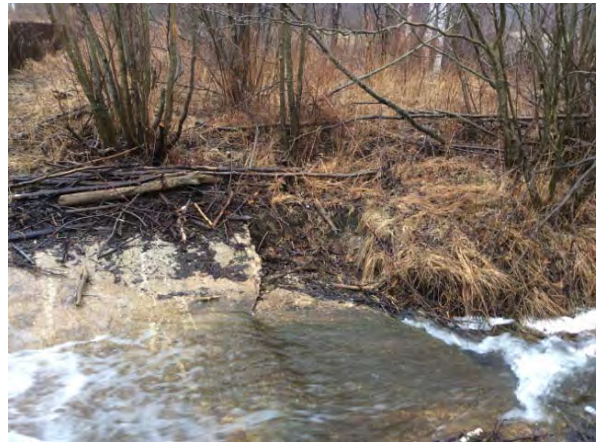
Washout/erosion on left downstream channel

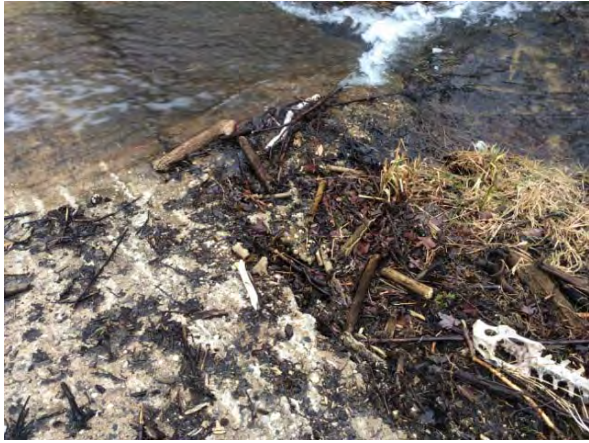
Washout/erosion on left downstream channel

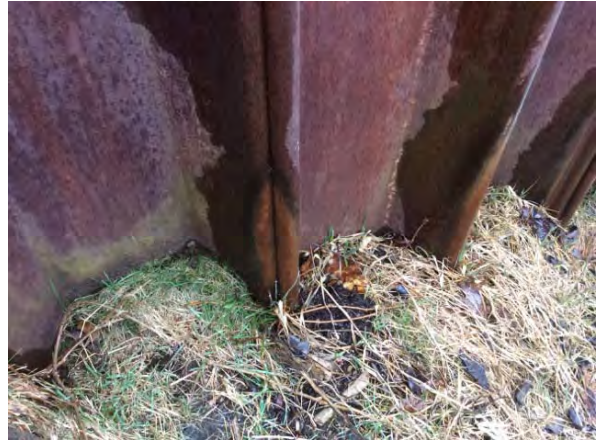
Seepage along downstream face of sheetpile at joints (typical)

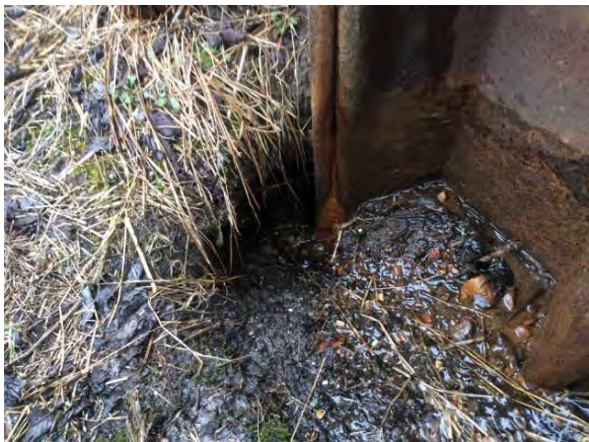
CONCRETE STRUCTURE: Check for erosion; location of cracking or spalling. If old or new; settlement; need for crack repairs. CONCRETE SPASHPAD – Fair condition. Portions have cracked and settled. It appears an animal burrow extends beneath the spillway and may cause further settlement or cracking.	
WALKWAY & RAILING: Check if in place or removed, condition, and if adequate protection provided. N/A	TRASHRACK OR LOG BOOM: Check if operable. N/A
EMERGENCY SPILLWAY: Size, type, and condition. N/A

Animal burrow on downstream face of left sheetpile wall. Depth > 5'

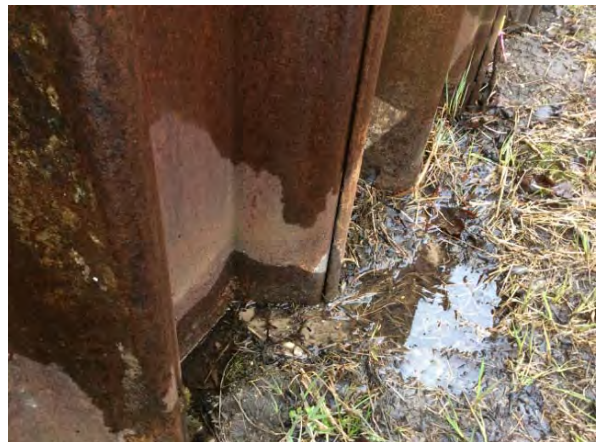
Standing water on downstream face of left sheetpile structure

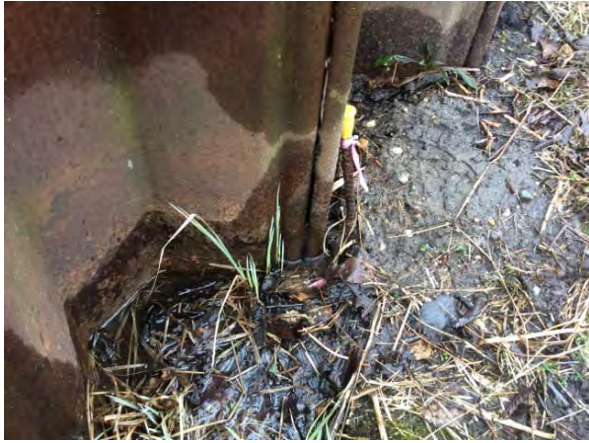
UPSTREAM	CROWN	DOWNSTREAM
VEGETATIVE COVER	GRASS WETLANDS	N/A - SHEETING	GRASS AND BRUSH
EROSION	NONE VISIBLE	NONE VISIBLE	NONE VISIBLE
SEEPAGE			MINOR ALONG SHEETPILE; SOME SPURTING OBSERVED ON LEFT SIDE OF SHEETPILE
SLIDES, SLUMPS & CRACKS	NONE VISIBLE	NONE VISIBLE	NONE VISIBLE
ANIMAL BURROWS	NONE VISIBLE	NONE VISIBLE	8" Dia burrow on left downstream toe of sheetpile. Extends under concrete spillway
WAVE ACTION PROTECTION	NATURAL WOODLANDS		N/A
REMARKS*

Spurting seepage through sheetpile on downstream face of left sheetpile structure

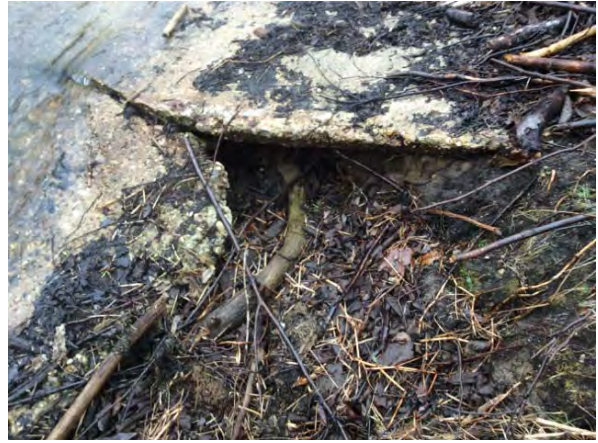
Washout/animal burrow on left downstream channel

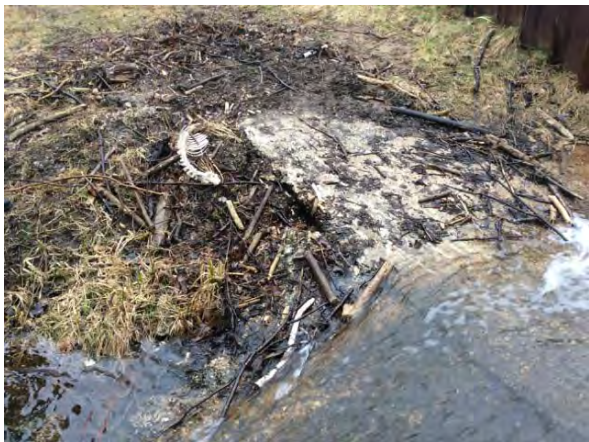
Washout/erosion on right downstream channel

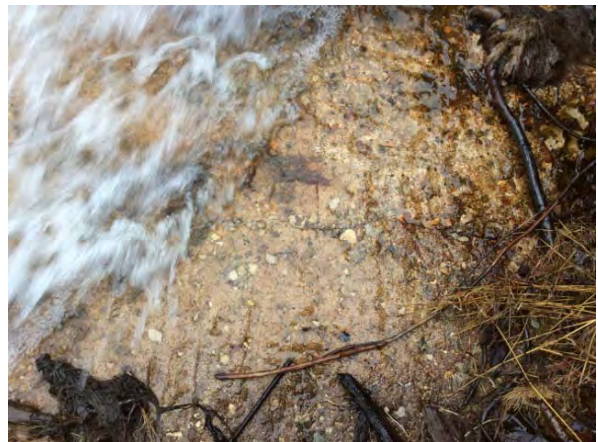
Transverse crack running along concrete spillway over void below concrete

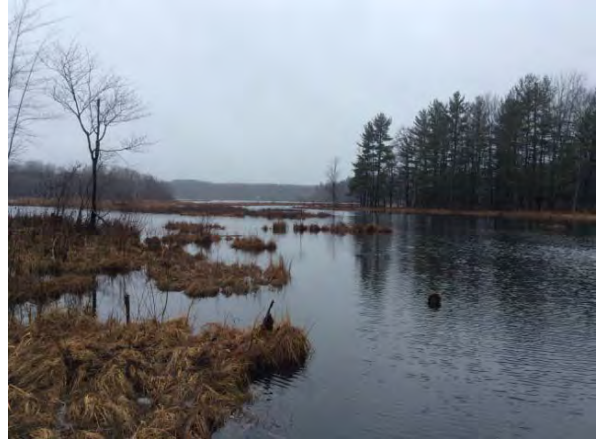
Impoundment

List work needed, how to be done, by whom, estimated cost, source of funds, recommended completion date. If emergency, to what extent. ADDITIONAL COMMENTS. SEDIMENT SHOULD BE REMOVED UPSTREAM OF THE STRUCTURE WHEN IT REACHES THE CREST ELEVATION.
Inspection Ordered By: <u>Jackie Fitzgerald</u> Mecosta County Drain Commissioner County Delegated Agent
